Analiza e Planit Rehabilitues të Aseteve në platformën EDAMS në KRU “Prishtina” dhe “Hidromorava”

KRU “Prishtina” SH.A.

KRU “Hidromorava” SH.A.

EDAMS - Planifikimi Rehabilitues (PH)

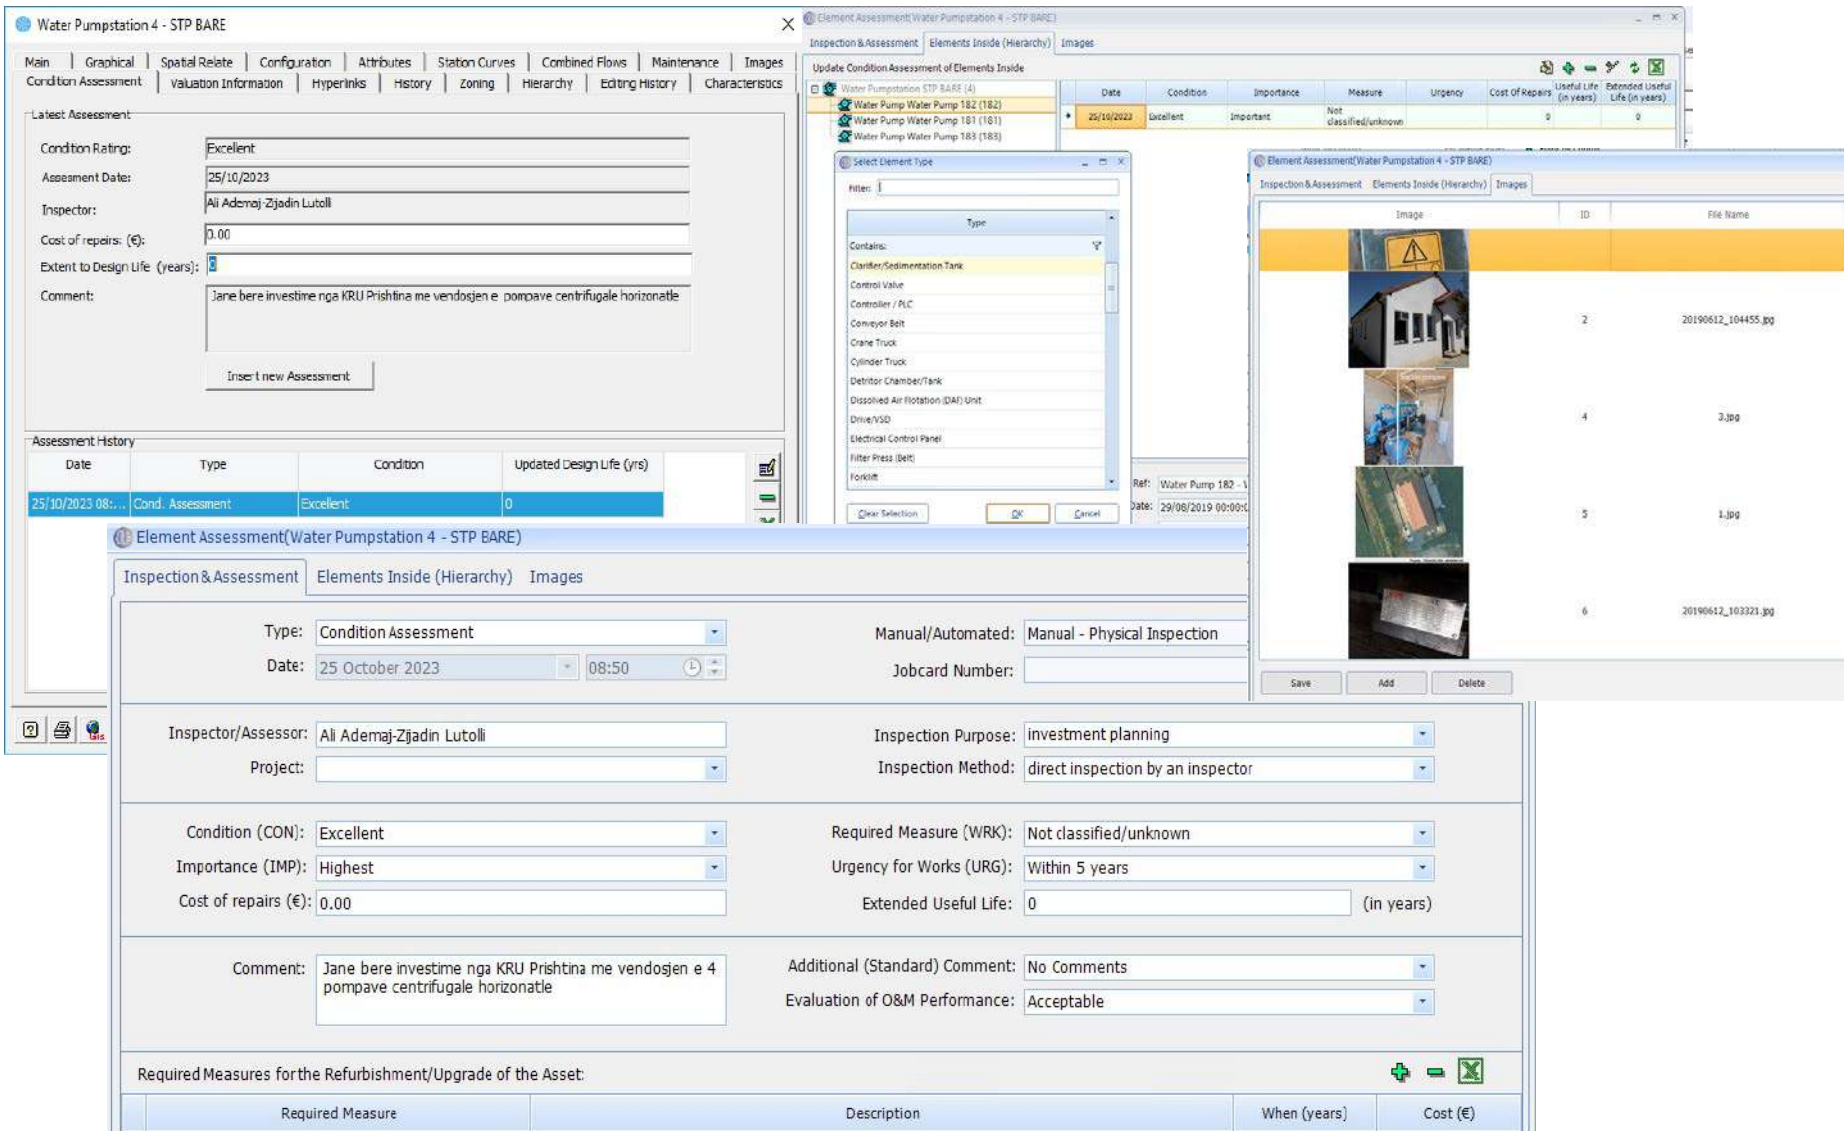
Prishtina: Vlerësimi i gjendjes në EDAMS

Water Pumpstation 4 - STP BARE

Condition Rating: **Excellent**
 Assessment Date: **25/10/2023**
 Inspector: **Ali Ademaj-Zjadin Lutoll**
 Cost of repairs (€): **0.00**
 Extent to Design Life (years): **0**
 Comment: **Jane bere investime nga KRU Prishtina me vendosjen e pompave centrifugale horizontale**

Condition (CON): **Excellent**
 Importance (IMP): **Highest**
 Cost of repairs (€): **0.00**
 Required Measure (WRK): **Not classified/unknown**
 Urgency for Works (URG): **Within 5 years**
 Extended Useful Life: **0** (in years)

Comment: **Jane bere investime nga KRU Prishtina me vendosjen e 4 pompave centrifugale horizontale**
 Additional (Standard) Comment: **No Comments**
 Evaluation of O&M Performance: **Acceptable**

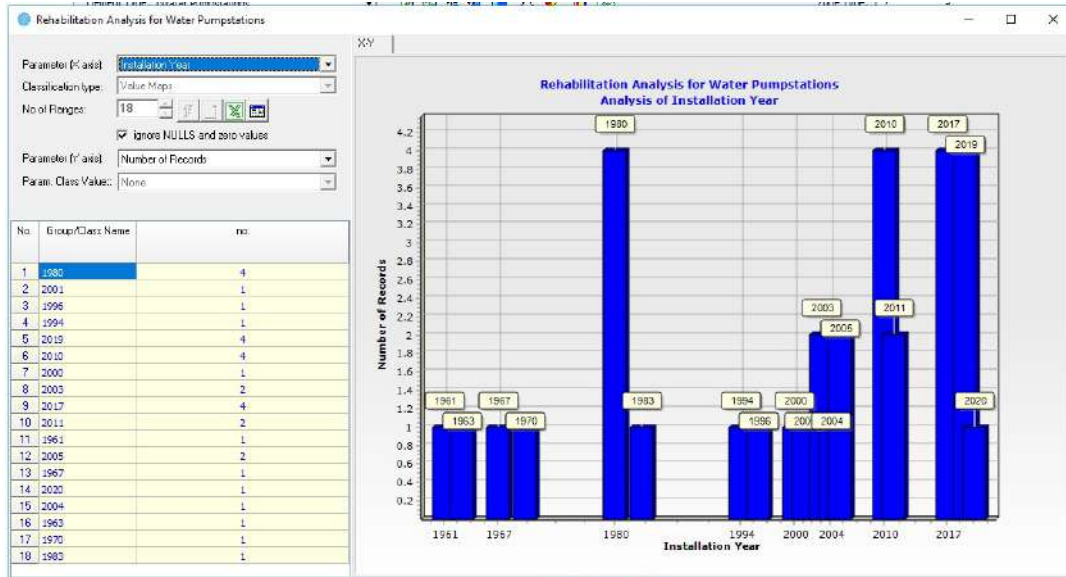
STP në bazë të vitit të Instalimit.

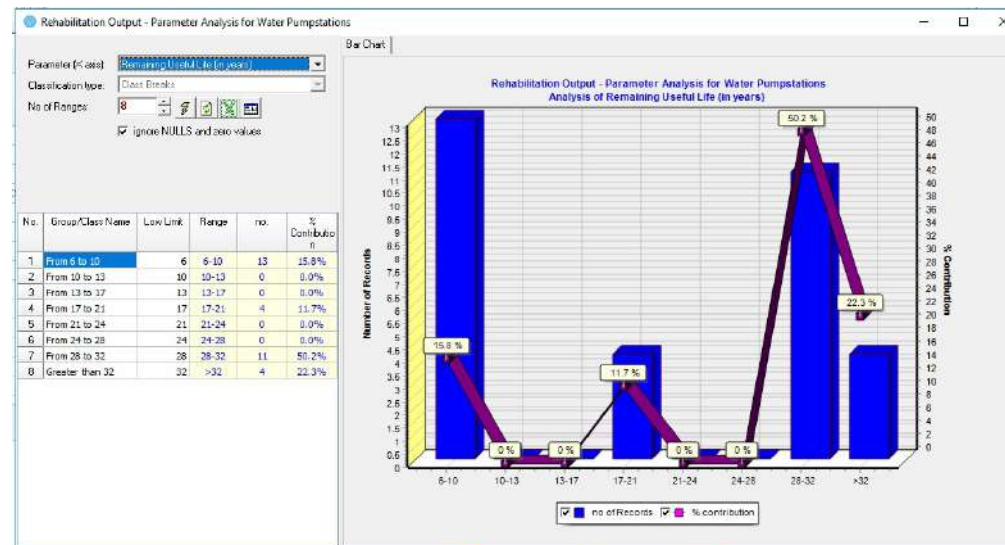
STP në bazë të vitit të mbetur të jetë gjatësisë së dizajnuar.

STP në bazë të jetëgjatësisë së mbetur të dobishme.

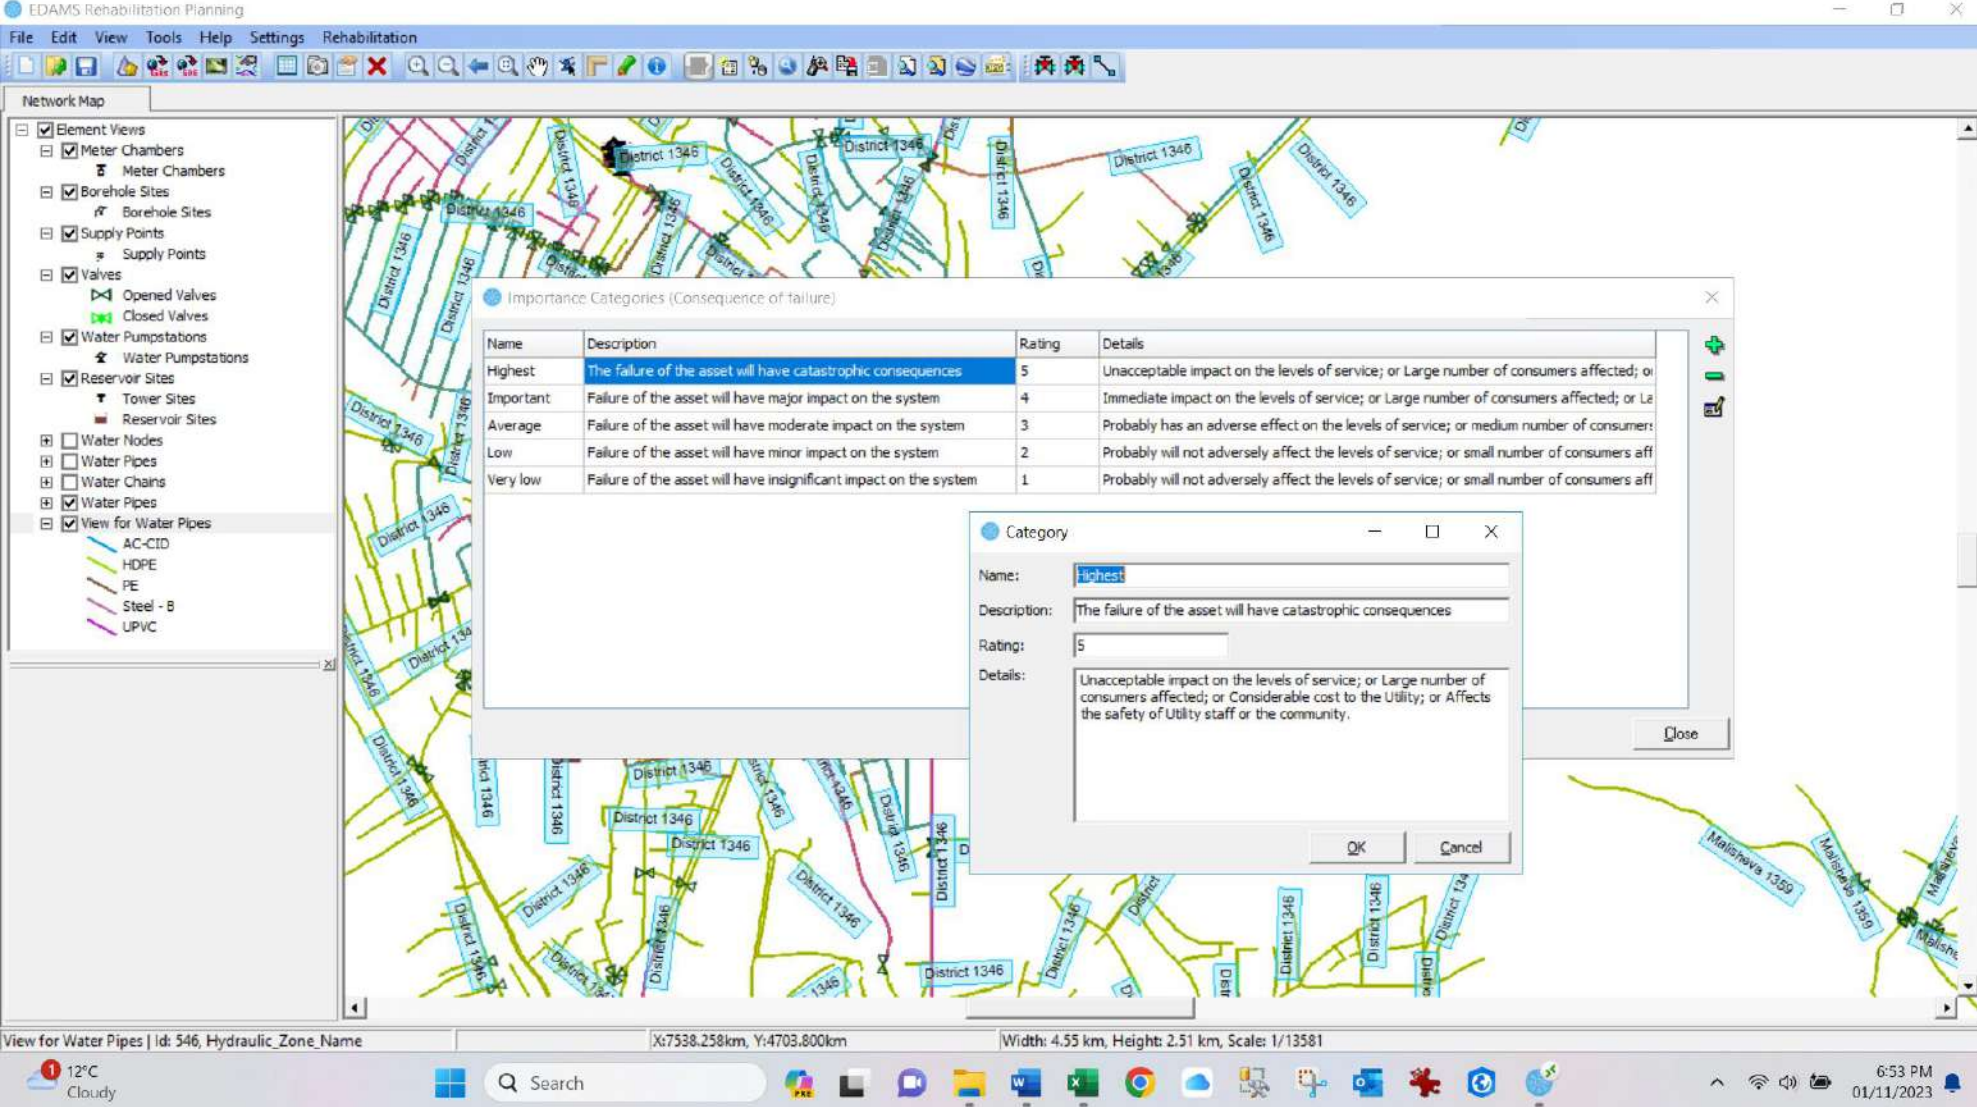
Kategorizimi sipas rëndësisë – Kons. e dështimit

Importance Categories (Consequence of failure)

Name	Description	Rating	Details
Highest	The failure of the asset will have catastrophic consequences	5	Unacceptable impact on the levels of service; or Large number of consumers affected; or
Important	Failure of the asset will have major impact on the system	4	Immediate impact on the levels of service; or Large number of consumers affected; or Le
Average	Failure of the asset will have moderate impact on the system	3	Probably has an adverse effect on the levels of service; or medium number of consumer
Low	Failure of the asset will have minor impact on the system	2	Probably will not adversely affect the levels of service; or small number of consumers aff
Very low	Failure of the asset will have insignificant impact on the system	1	Probably will not adversely affect the levels of service; or small number of consumers aff
